**Flood Control Project Maintenance
Levee Inspections**

Fall 2018 Levee Maintenance Deficiency Summary Report

Sacramento River Basin

**Flood Control Project Maintenance
Levee Inspections****LMA District Cover Sheet
Fall 2018 Levee Inspection Results****Sacramento Maintenance Yard Sacramento Bypass**

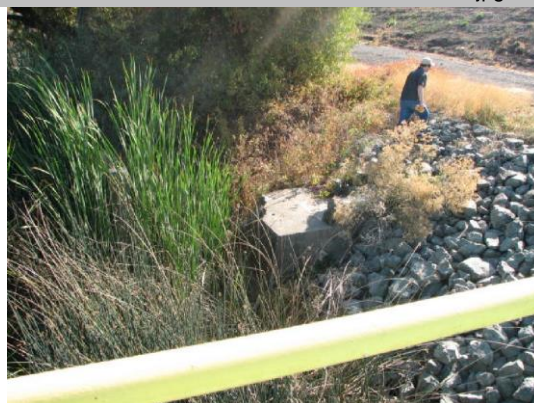
Photo 1 of 3 : UCIP_FA_2018_44787_20605.jpg

LM Start	1.09	Rating **	A/W	Issue No.	16
LM End	1.09	Issue Type +	Ma	Location *	
Category	Supplemental			GPS Latitude/Longitude	
				Start	End
Item	DWR UCIP LMA Responsibility			38.602169 °	38.602169 °
				-121.579000 °	-121.579000 °
DWR ID	19076				
Comment Code					
Inspector Comment					
FS_ID:44787 DS_ID:19076 EP_NO: N/A Repair Type: No Action Needed Crossing Status: Found UCIP Comments: A concrete saddle found on slough/drainage. No pump was found on LS and no structure/pipe found on WS. FIELD_STRUCT_DESC: *ABANDONED* 36-inch corrugated metal drainage pipe through the levee, at an unknown depth. Grouted in place. Remains of concrete structure found on the landside (LS). [Additional Reference(s): USACE Sacramento O&M Manual 122.1, August 1955, (RM 174)]. FS Date: 4/28/2015 2:44:05 PM

Landside view: overview

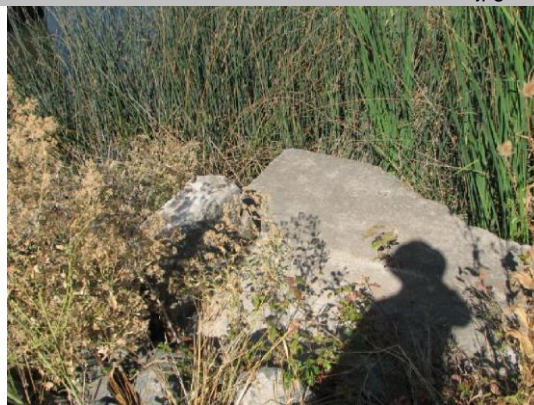
Photo 2 of 3 : UCIP_FA_2018_44787_20604.jpg

Landside view: remaining of concrete structure

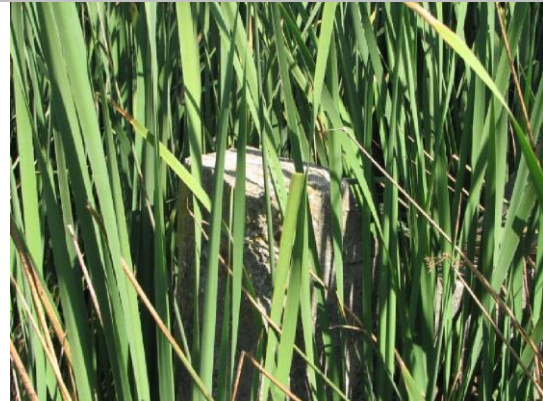
Photo 3 of 3 : UCIP_FA_2018_44787_20606.jpg

LM Start	1.09	Rating **	A/W	Issue No.	16 (cont)	
LM End	1.09	Issue Type +	Ma	Location *		
Category	Supplemental			GPS Latitude/Longitude		
				Start	End	
Item	DWR UCIP LMA Responsibility			38.602169 °	38.602169 °	
				-121.579000 °	-121.579000 °	
DWR ID	19076					
Comment Code						
Inspector Comment						
FS_ID:44787 DS_ID:19076 EP_NO: N/A Repair Type: No Action Needed Crossing Status: Found UCIP Comments: A concrete saddle found on slough/drainage. No pump was found on LS and no structure/pipe found on WS. FIELD_STRUCT_DESC: *ABANDONED* 36-inch corrugated metal drainage pipe through the levee, at an unknown depth. Grouted in place. Remains of concrete structure found on the landside (LS). [Additional Reference(s): USACE Sacramento O&M Manual 122.1, August 1955, (RM 174)]. FS Date: 4/28/2015 2:44:05 PM

Landside view: remaining of concrete structure on drainage/slough

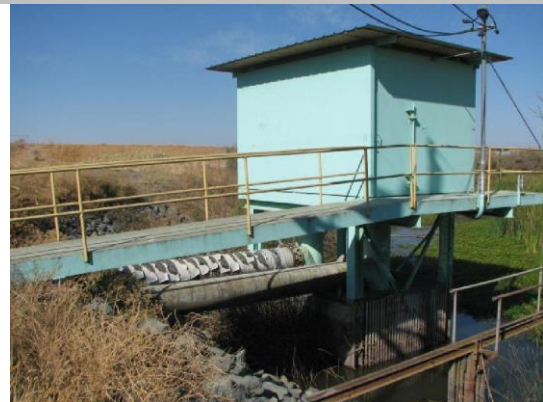
Photo 1 of 3 : UCIP_FA_2018_44783_20611.jpg

Comment Code					
Inspector Comment					
FS_ID:44783 DS_ID:19066 EP_NO: 13616 Repair Type: Non-Urgent Crossing Status: Found UCIP Comments: After more investigation depressions are from water run off. erosion repair needed FIELD_STRUCT_DESC: [Agricultural Drainage Pumping System] 1 of 2: 24-inch concrete encased steel discharge pipeline through the right bank (north) levee of the Sacramento Bypass, 6.33 feet below the crown. Siphon breaker on the waterside (WS). Vertical galvanized iron pipe trash rack on the inlet structure. (24-inch pipeline authorized under Permit No. 13616, 1995 - Reclamation District No. 537 [revised]). FS Date: 4/28/2015 2:43:01 PM

Landside view: pumping plant overview

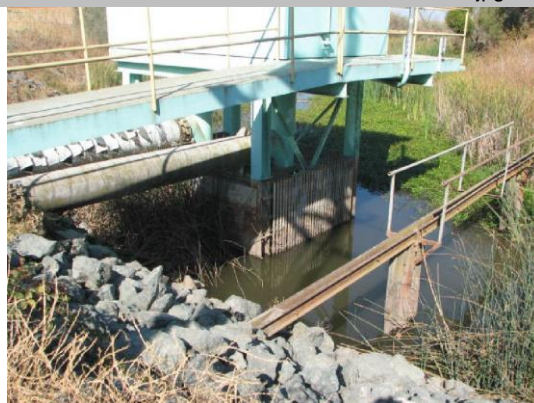
Photo 2 of 3 : UCIP_FA_2018_44783_20609.jpg

Comment Code						
Inspector Comment						
FS_ID:44783 DS_ID:19066 EP_NO: 13616 Repair Type: Non-Urgent Crossing Status: Found UCIP Comments: After more investigation depressions are from water run off. erosion repair needed FIELD_STRUCT_DESC: [Agricultural Drainage Pumping System] 1 of 2: 24-inch concrete encased steel discharge pipeline through the right bank (north) levee of the Sacramento Bypass, 6.33 feet below the crown. Siphon breaker on the waterside (WS). Vertical galvanized iron pipe trash rack on the inlet structure. (24-inch pipeline authorized under Permit No. 13616, 1995 - Reclamation District No. 537 [revised]). FS Date: 4/28/2015 2:43:01 PM

Landside view: vertical GI pipes in inlet structure.

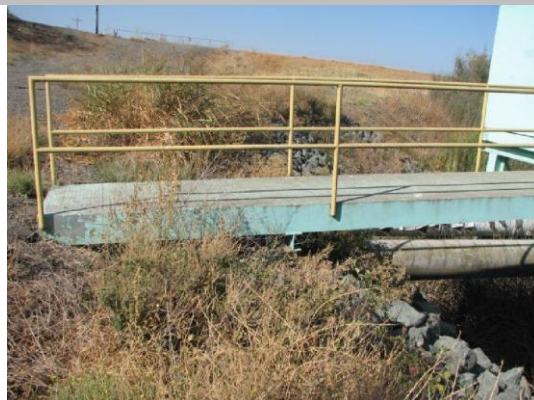
Photo 3 of 3 : UCIP_FA_2018_44783_20608.jpg

Landside view: walkway to the pump house.

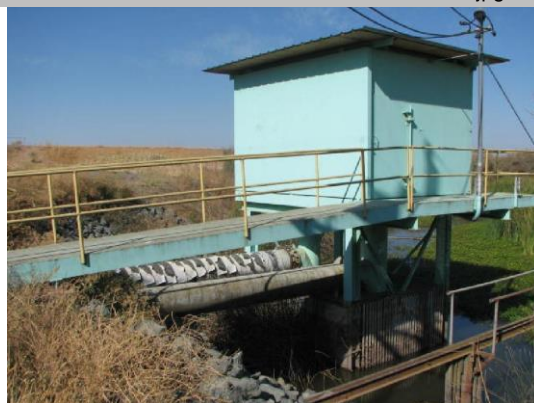
Photo 1 of 3 : UCIP_FA_2018_44784_20619.jpg

Comment Code					
Inspector Comment					
FS_ID:44784 DS_ID:19079 EP_NO: 13616 Repair Type: Non-Urgent Crossing Status: Found UCIP Comments: Horizontal Air vent on waterside slope. Green vegetation and depressions also found on waterside slope. FIELD_STRUCT_DESC: [Agricultural Drainage Pumping System] 2 of 2: 20-inch concrete encased steel discharge pipeline through the right bank (north) levee of the Sacramento Bypass, 6.33 feet below the crown. Siphon breaker on the waterside (WS). Vertical galvanized iron pipe trash rack on the inlet structure. (24-inch pipeline authorized under Permit No. 13616, 1995 - Reclamation District No. 537 [revised]). FS Date: 4/28/2015 2:43:26 PM

Landside view: overview of pumping plant

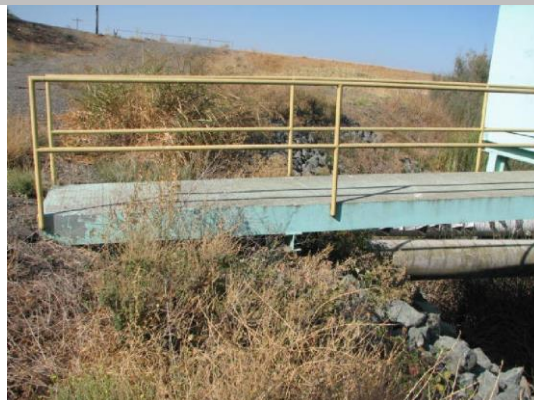
Photo 2 of 3 : UCIP_FA_2018_44784_20618.jpg

Landside view: walkway to the pumping plant

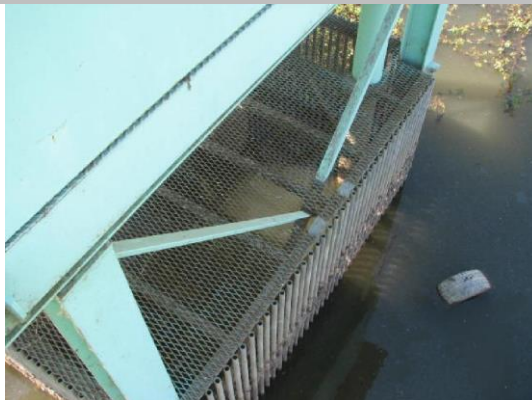
Photo 3 of 3 : UCIP_FA_2018_44784_20617.jpg

Comment Code						
Inspector Comment						
FS_ID:44784 DS_ID:19079 EP_NO: 13616 Repair Type: Non-Urgent Crossing Status: Found UCIP Comments: Horizontal Air vent on waterside slope. Green vegetation and depressions also found on waterside slope. FIELD_STRUCT_DESC: [Agricultural Drainage Pumping System] 2 of 2: 20-inch concrete encased steel discharge pipeline through the right bank (north) levee of the Sacramento Bypass, 6.33 feet below the crown. Siphon breaker on the waterside (WS). Vertical galvanized iron pipe trash rack on the inlet structure. (24-inch pipeline authorized under Permit No. 13616, 1995 - Reclamation District No. 537 [revised]). FS Date: 4/28/2015 2:43:26 PM

Landside view: vertical GI pipe trash rack in inlet structure.

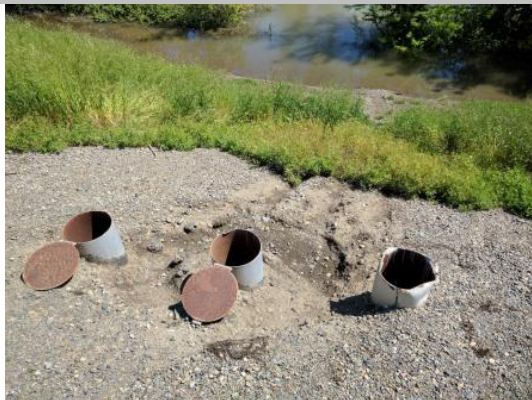
Photo 1 of 1 : FA_2018_ST0008_284_14_20180904_00001.jpg

LM Start	1.29	Rating **	M	Issue No.	14
LM End	1.29	Issue Type +	En	Location *	WS
Category	Earthen Levee			GPS Latitude/Longitude	
				Start	End
Item	Encroachments			38.601246 °	38.601246 °
				-121.582469 °	-121.582469 °
DWR ID	DWR_ST0008_01_s _ 2017_14				
Comment Code					
PI : Pipe					
Inspector Comment					
Erosion on WS slope from siphon breaker water.

View of erosion on waterside levee slope. Spring 2017.

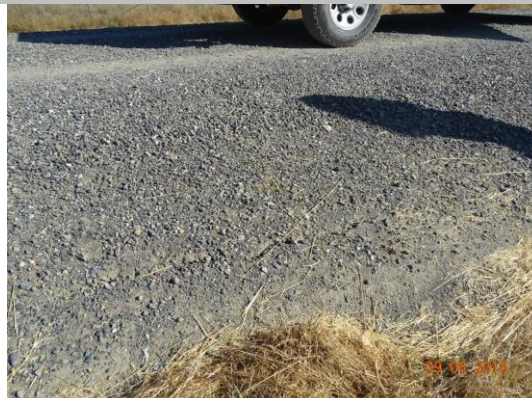
Photo 1 of 1 : FA_2018_ST0008_284_7_20180924_00013.jpg

LM Start	1.43	Rating **	A/W	Issue No.	7
LM End	1.59	Issue Type +	Ma	Location *	WS
Category	Supplemental			GPS Latitude/Longitude	
				Start	End
Item	2017 USACE Erosion Survey, DRAFT			38.600456 °	38.599713 °
				-121.584883 °	-121.587668 °
DWR ID	DWR_ST0008_01_f_2018_7				
Comment Code					
Inspector Comment					
2017 Site ID: SAP 1.4 R					
Status: Critical					
2017 Field Notes: New site, immediately upgraded to critical. Start of slump failure, deep cracks along levee crest, concern that a large slump failure will occur from the next heavy rain.					
Site History:					
DWR Inspector Comment: Did not observe significant damage on the waterside slope. Minor craking on the crown. Recommend monitoring.

View of the cracking on the crown. Fall 2018.

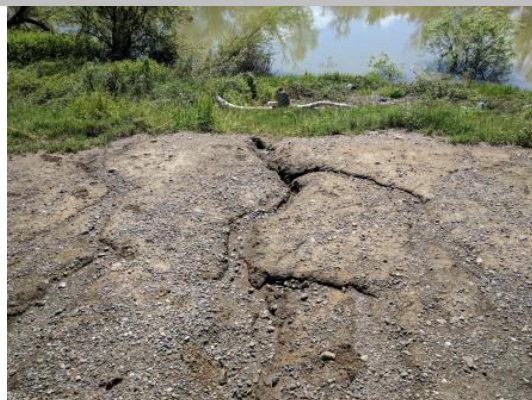
Photo 1 of 1 : FA_2018_ST0008_284_15_20180904_00002.jpg

LM Start	1.74	Rating **	A/W	Issue No.	15
LM End	1.74	Issue Type +	Ma	Location *	WS
Category	Earthen Levee			GPS Latitude/Longitude	
				Start	End
Item	Erosion / Bank Caving			38.599546 °	38.599546 °
				-121.590235 °	-121.590235 °
DWR ID	DWR_ST0008_01_s_2018_15				
Comment Code					
E1 : Note and monitor erosion site.					
Inspector Comment					
Runoff erosion on oversized levee section. Lcoated on waterside levee slope. Recommend monitoring.

View of erosion on waterside slope. Spring 2017.

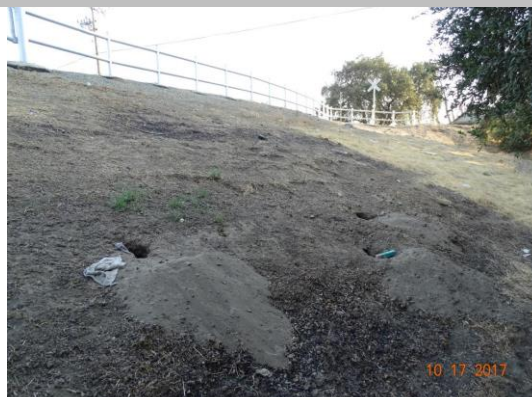
Photo 1 of 2 : FA_2018_ST0008_285_2_20180904_00004.jpg

LM Start	0.03	Rating **	M	Issue No.	2
LM End	0.03	Issue Type +	Ma	Location *	LS
Category	Earthen Levee			GPS Latitude/Longitude	
				Start	End
Item	Animal Control			38.602613 °	38.602613 °
				-121.556021 °	-121.556021 °
DWR ID	DWR_ST0008_02_s_2016_2				
Comment Code					
A3 : No rodents visible, but rodent burrows visible; need to backfill and compact or grout burrows.					
Inspector Comment

Updated view of rodent holes on landside slope. Fall 2017.

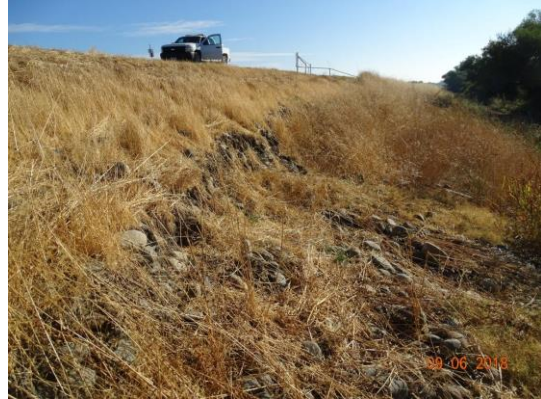
Photo 1 of 4 : FA_2018_ST0008_285_1_20180906_00009.jpg

LM Start	1.26	Rating **	A/W	Issue No.	1
LM End	1.79	Issue Type +	Ma	Location *	
Category	Supplemental			GPS Latitude/Longitude	
				Start	End
Item	2017 Storm Damage			38.597023 °	38.594527 °
				-121.577558 °	-121.586638 °
DWR ID	DWR_ST0008_02_f_2017_1				
Comment Code					
Inspector Comment					
Levee Evaluation Comments					
Description:					
Site ID No:260					
Site Designation:LMA-55					
Repair Type: Erosion					
Rating:Area of Concern					
Field Date:6/5/2017					
Notes: Minor wavewash on landside levee slope; no active erosion; no cross section taken, photo only. The erosion is not within the prism. Sac Yard will fix after vegetation gets burned. Fall 2018.

View of the worst section of erosion, just past the gate near the end of the unit. Fall 2018.

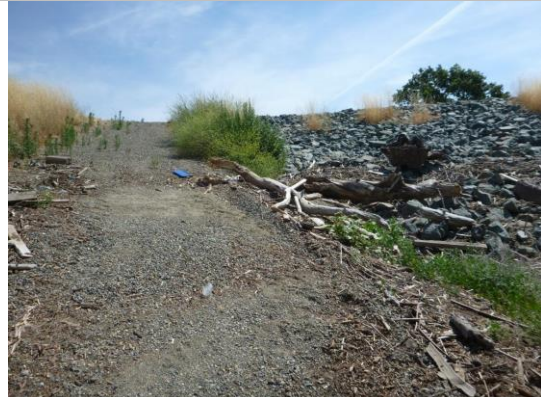
Photo from storm site evaluations.

Notes: Minor wavewash on landside levee slope; no active erosion; no cross section taken, photo only. The erosion is not within the prism. Sac Yard will fix after vegetation gets burned. Fall 2018.

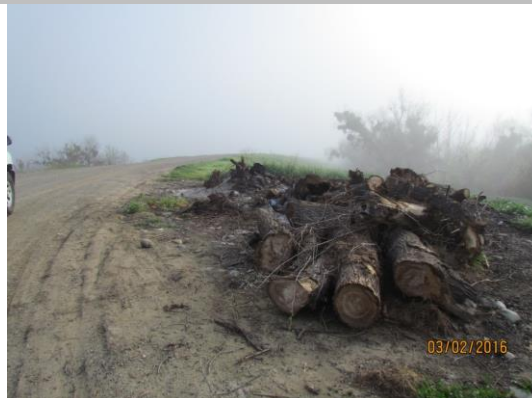
Photo 2 of 2 : FA_2018_ST0008_285_5_20180904_00007.jpg

LM Start	1.77	Rating **	A/W	Issue No.	5 (cont)	
LM End	1.77	Issue Type +	Ma	Location *	LS	
Category	Earthen Levee			GPS Latitude/Longitude		
				Start	End	
Item	Encroachments			38.594743 °	38.594743 °	
				-121.586556 °	-121.586556 °	
DWR ID	DWR_ST0008_02_s_2016_5					
Comment Code						
PR : Prunings						
Inspector Comment						
This is a seasonal pile but gets burned by the LMA each year.

View of the firewood on the landward side of the levee looking upstream. Spring 2016.

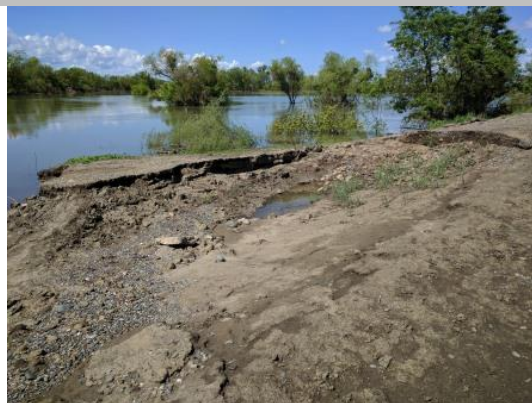
Photo 1 of 1 : FA_2018_ST0008_285_8_20180904_00008.jpg

LM Start	1.77	Rating **	A/W	Issue No.	8
LM End	1.77	Issue Type +	Ma	Location *	WS
Category	Earthen Levee			GPS Latitude/Longitude	
				Start	End
Item	Erosion / Bank Caving			38.594710 °	38.594710 °
				-121.586582 °	-121.586582 °
DWR ID	DWR_ST0008_02_s_2017_8				
Comment Code					
E1 : Note and monitor erosion site.					
Inspector Comment					
Runoff location, but not within the levee prism. Recommend monitoring.

View of erosion on waterside levee slope. Spring 2017.
